April 14, 2016

# SAVANNAH RIVER REMEDIATION UPDATE

SAVANNAH RIVER SITE • AIKEN, SC • www.SRRemediation.com

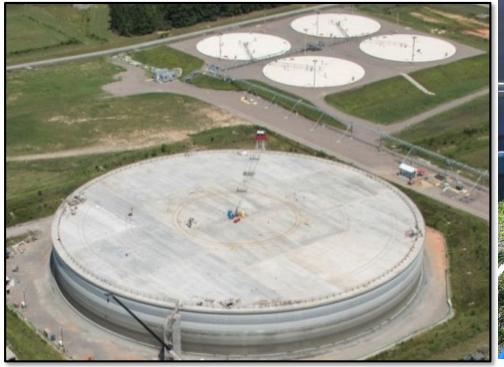
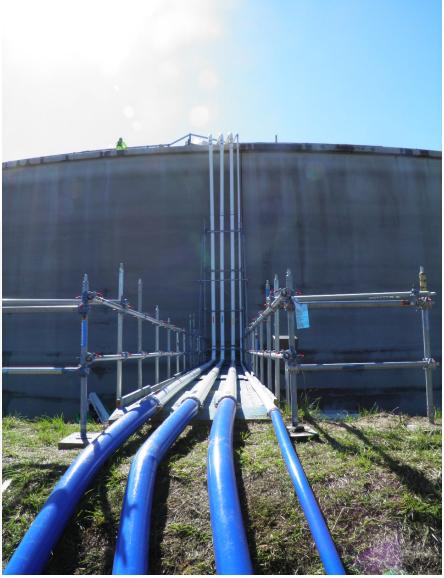
# SRR Technical Issue: SDU 6

#### Leak Repairs

- 30 million gallon construction
- Unable to pass water-tightness test with dye
- Install a liner
- Retest tank
- Under budget
- On track to meet system plan need date

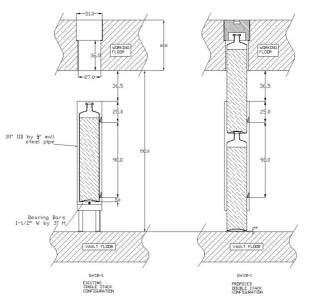
#### Canister Double Stack

- Work includes:
  - Modify existing locations to store two canisters each (from 2,254 to 4,508)
  - Remove existing crossbar canister support; lower canister supported on vault floor
  - Upper canister placed on top of lower canister
  - Upper canister Shield plug redesigned for equivalent radiological protection
  - Scheduled to begin double stacking in June
